# PROGRAM CHIP REPLACEMENT - MODEL LDE740 CONSOLE

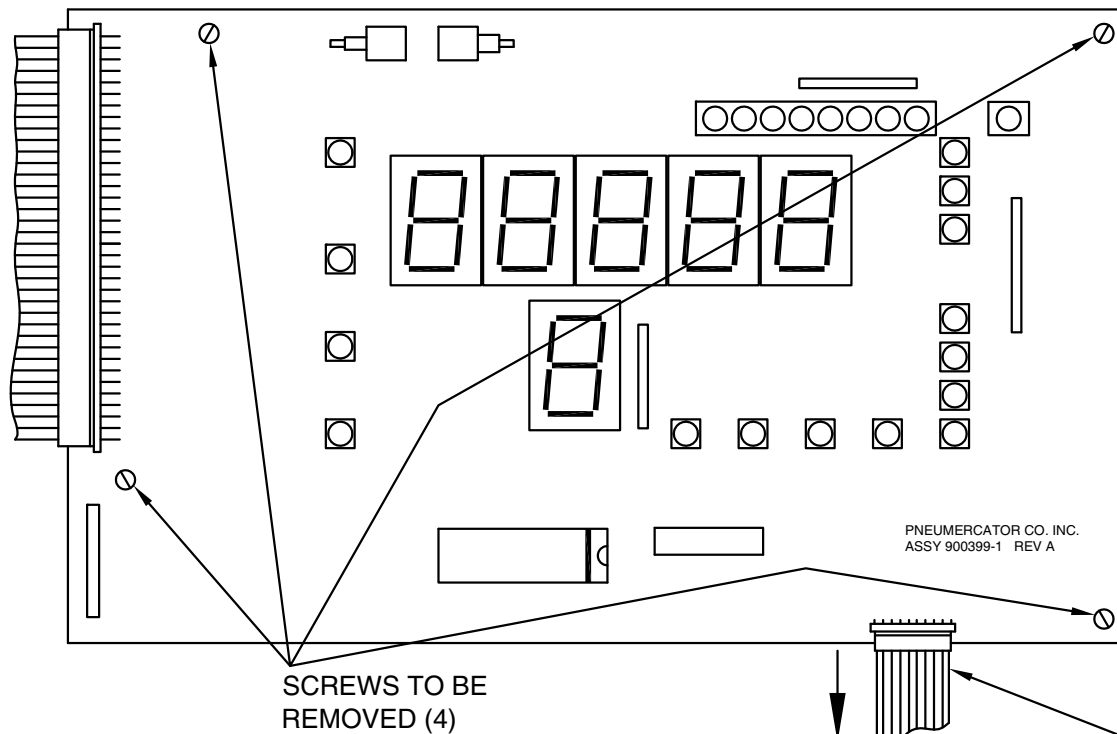
**FIGURE 1**

- 1) Disconnect power and open lid.
- 2) Disconnect Display Board Harness, remove (4) screws, and lift Display Board. See figure 1.
- 3) Remove old Program Chip (a chip puller should be used). See figure 2.
- 4) Replace w/new Program Chip (note orientation of notch).
- 5) Replace Display Board and reconnect Display Board Harness.
- 6) Any damage to the unit from this procedure is not the responsibility of Pneumercator Co.
